Kenmare City Memorial Hall Evaluation Report

City of Kenmare
Kenmare, North Dakota

Ackerman-Estvold Project No. R21098

July 2021

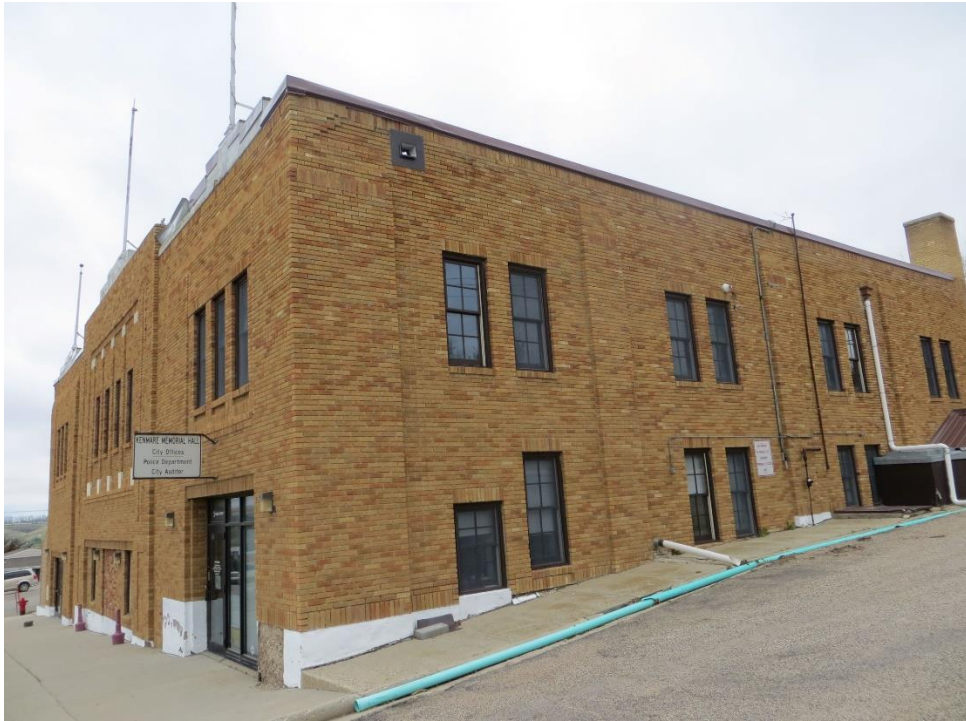
FIG. 3 SOUTH EAST BUILDING ELEVATION

- A. Face of existing stone base is spalling and cracking from the face of the SE corner of the building and starting to spaul from the west side of the SE entrance, NW Library entrance and south elevation. Deputy Auditor noted that there is water damage in the interior SE corner of her office. It was noted that a new overflow scupper was cut into the exterior parapet wall on the SE corner. This scupper dumps directly down to the SE corner of the building onto the concrete sidewalk bellow. The exterior concrete sidewalk that is adjacent to the SE corner of the building is pulling away at the caulked joint. This joint should be re-caulked to help stop the flow of water into the building.

- 1) Remediation: Add new downspout to match existing and extend to the curb. Repoint existing face brick at scupper location. Re-caulk existing concrete sidewalk joint. Remove existing spauled stone base and replace with precast concrete panel to match.

- 2) Estimated cost: \$6,000.

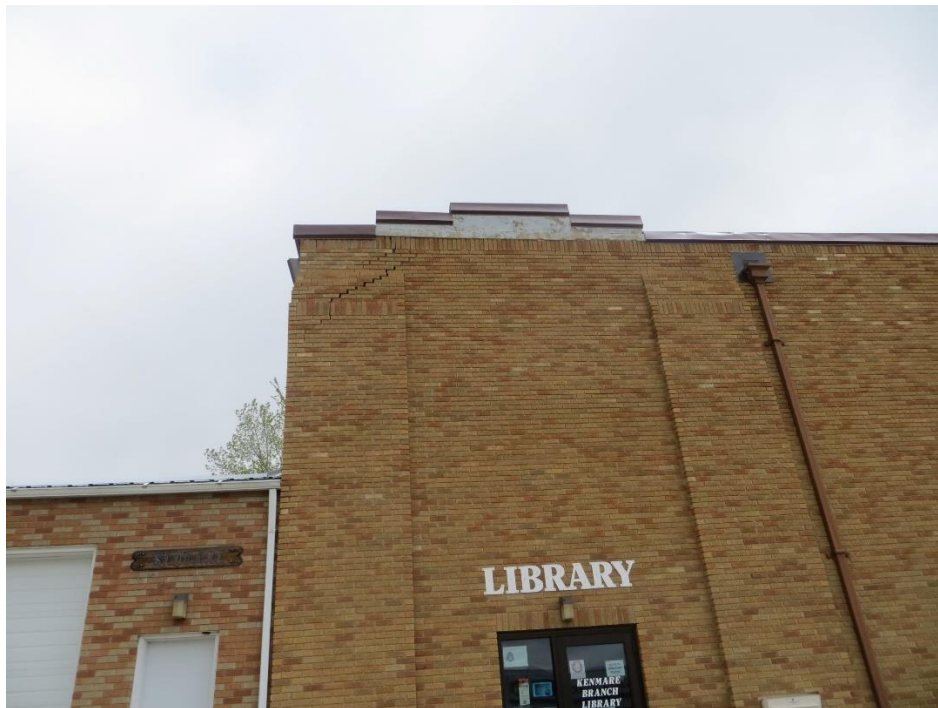
FIG. 4 NORTHWEST CORNER OF BUILDING

- B. The existing exterior face brick is showing signs of cracking at the upper parapets on the SE, SW, NE, NW, & SW corners, and north parapet of the building. This seems to be the result of the existing roof pulling away from the parapet and water being able to find its way behind the brick. The NE corner brick cracking has been repaired by filling in the cracks with grout, but the wall & chimney seem out of plumb. The existing metal coping at the top of the parapet is pulling away and being ripped off the parapet on the NW corner.
- 1) Remediation: Re-point existing face brick.
 - 2) Estimated cost: \$1,000.

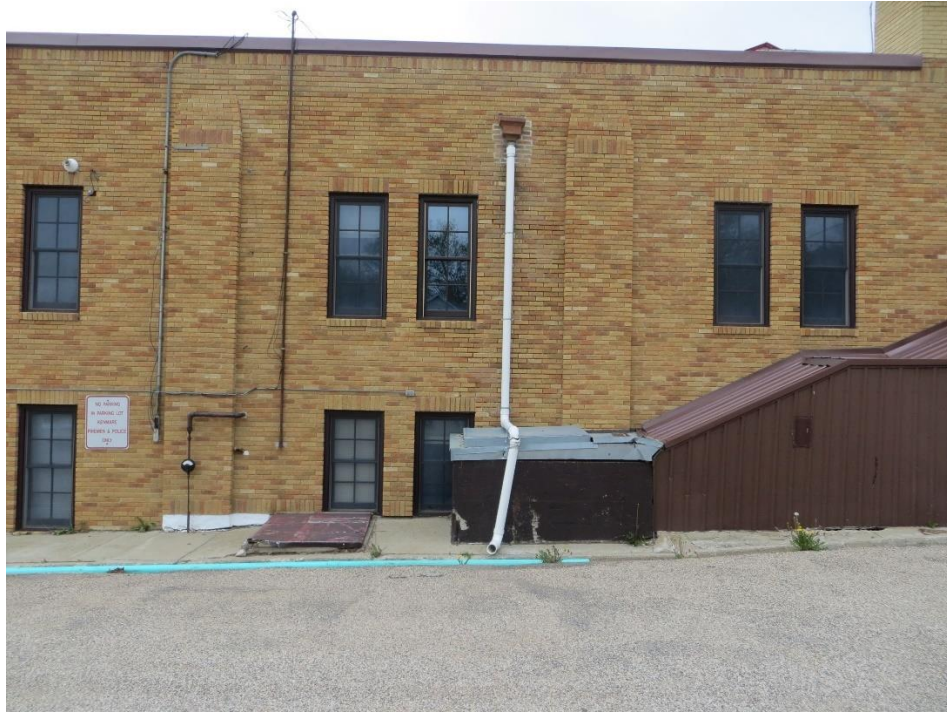
FIG. 5 EAST BUILDING ELEVATION AT ROOF SCUPPER

- C. The existing exterior face brick grout is deteriorated on the east side of the building under the existing roof scupper. This grout deterioration is due to the water running over the face of the brick and freezing. The face brick at the roof scupper has been re-pointed for about 2'-0". The grout deterioration runs down the entire height of the building. A downspout and extension to the curb have been added.
- 1) Remediation: Re-point existing face brick.
 - 2) Estimated cost: \$2,500.

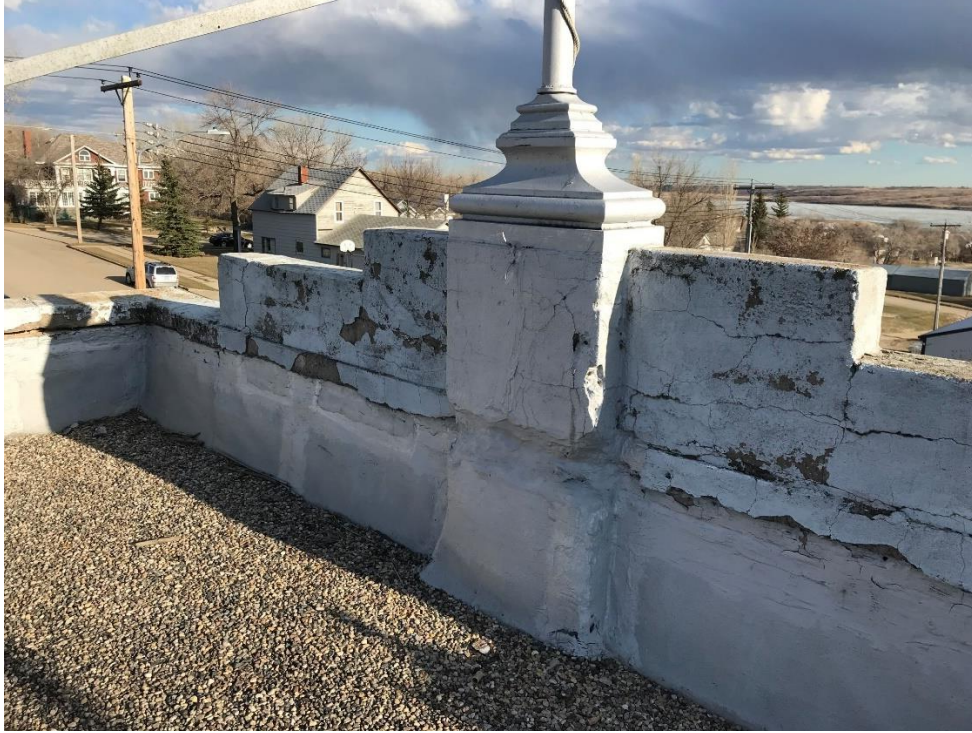
FIG. 6 BACK OF EXISTING STONE FLAG CAP

- F. The storage building addition on the SE corner is missing the metal roof edge transition piece on the north side.
- G. The existing stone flag pedestal and steps are cracking and crumbling. The metal coping that has been installed to cover the pedestal, steps and parapet caps has been torn off in some places due to high winds.

- 1) Remediation: Remove all existing concrete/stone cap. Repoint all brick at parapet.
 - 2) Replace pre-cast stone flag pedestal & adjacent steps, add all new wood parapet blocking, install new metal coping (**Option 1**).

- 3) Estimated cost: \$34,000.

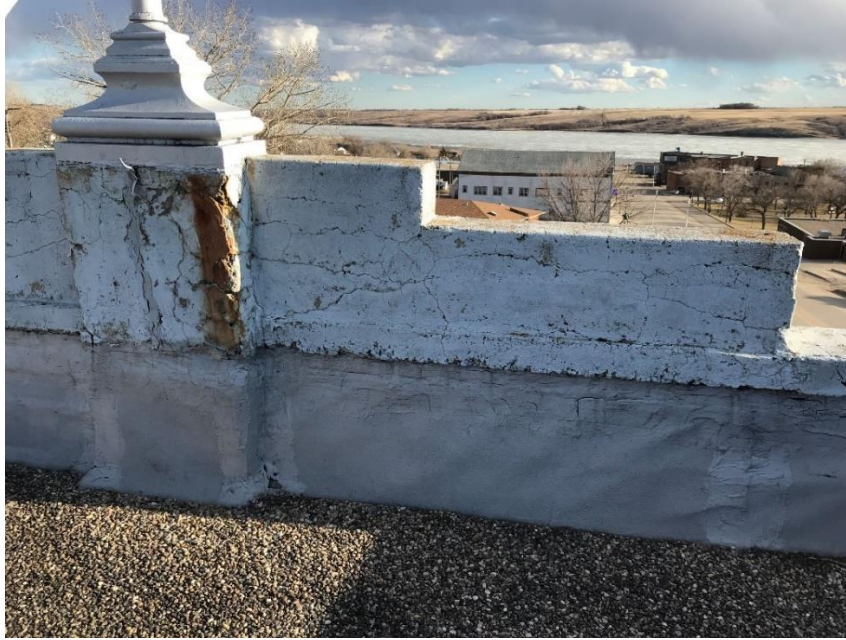
FIG. 7 BACK OF EXISTING STONE CAP

- H. The existing stone parapet caps and stepped flag pedestals are cracked and crumbling. Which is allowing water to penetrate the face brick below and crumble the masonry grout.
- 1) Remediation: Remove all existing concrete/stone cap. Repoint all brick at existing parapet.
 - 2) Add new pre-cast stone coping, flag pedestal & adjacent steps. Repoint all brick at parapet. (**Option 2**).
 - 3) Estimated cost: \$38,000.

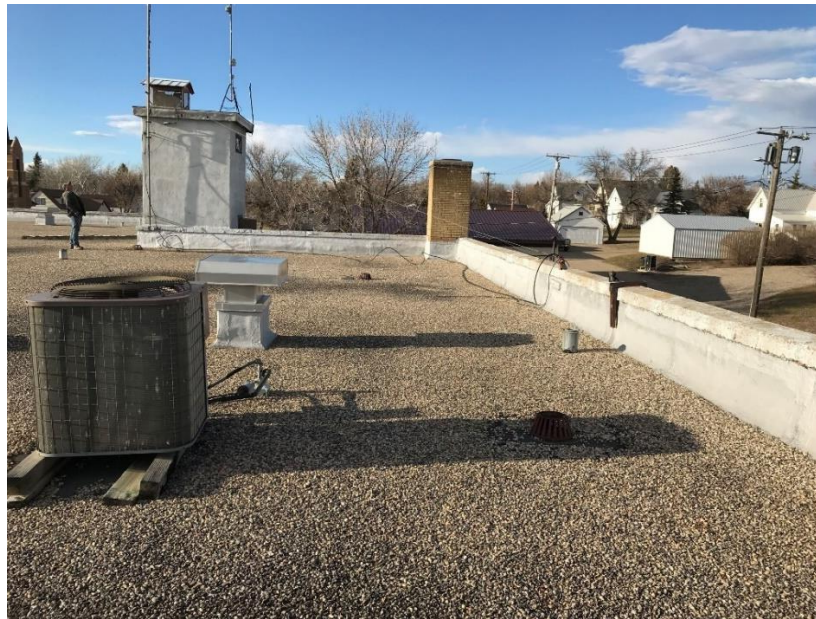
FIG. 8 EXISTING ROOF

- I. The existing roof is a ballasted membrane roof, which has the membrane pulling away from the parapet walls and allowing water to infiltrate the masonry and disintegrate the existing masonry grout.
 - 1) Remediation: Remove existing roof insulation, roof membrane and existing roof ballast.
 - 2) New EPDM roof membrane, new roof insulation and counter flashing.
 - 3) Estimated cost: \$175,000.

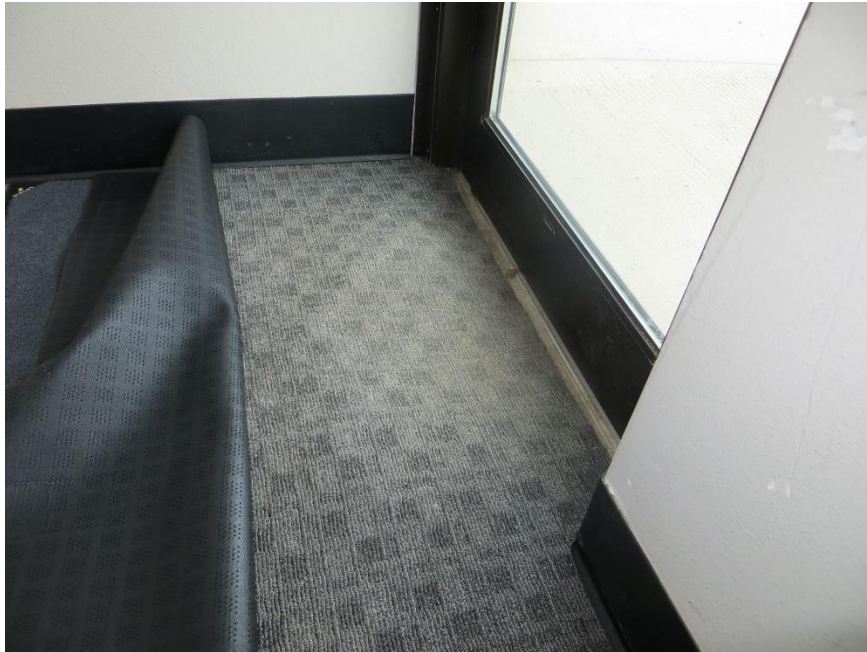
FIG. 9 CONCRETE FLOOR BUMP AT SOUTHEAST ENTRANCE

- A. There is a large bump in the concrete floor below the carpeting at the southeast entrance. This bump creates a tripping hazard, as well as a barrier for ADA accessibility.
 - 1) Remediation:
 - i. Grind down bump in concrete floor and prep concrete floor with appropriate floor leveler prep material.
 - 2) Estimated cost: \$300.

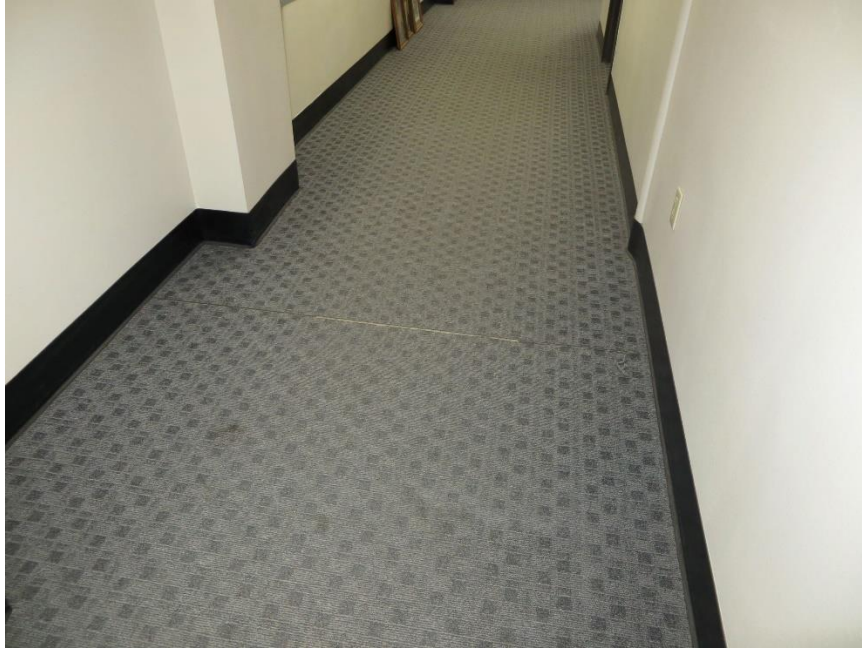
FIG. 10 CORRIDOR CARPETING

- B. The existing carpeting was installed in the 1997 renovation and is showing signs of traffic wear, tears, and stains. The existing carpeting should be removed and replaced with carpet tile.
 - 1) Remediation: Remove existing carpeting, adhesive, & vinyl base. Prep floor for new carpet tile.
 - 2) Install new carpet tile & vinyl base.
 - 3) Estimated cost: \$23,000.

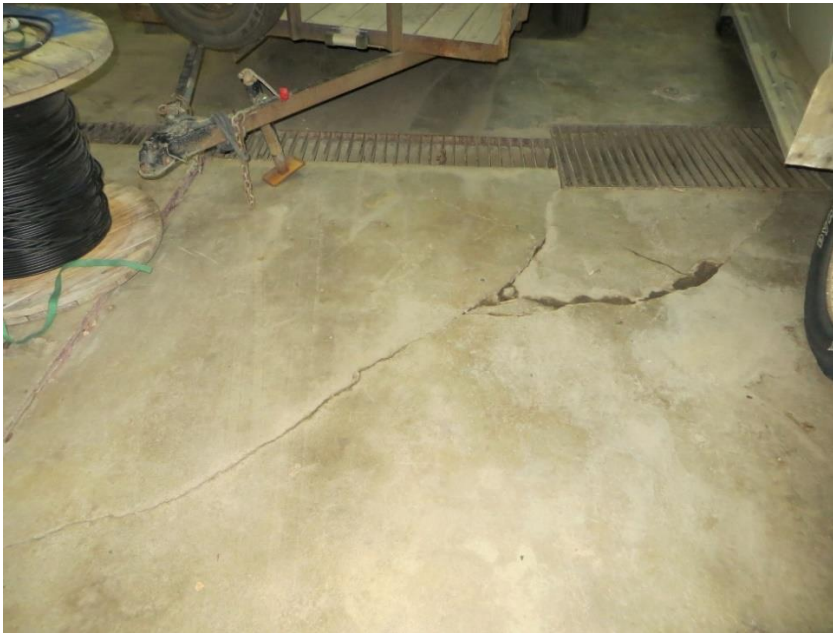
FIG. 11 GARAGE FLOOR CRACKS

- C. The concrete floor in the City Storage garage has large cracks and slab heaving at a section by the floor drain. This section of concrete slab should be removed and re-poured to slope to the floor drain.
- 1) Remediation: Removal of cracked sections of existing concrete slab.
 - 2) Re-pour new section of concrete slab.
 - 3) Estimated cost: \$2,500.

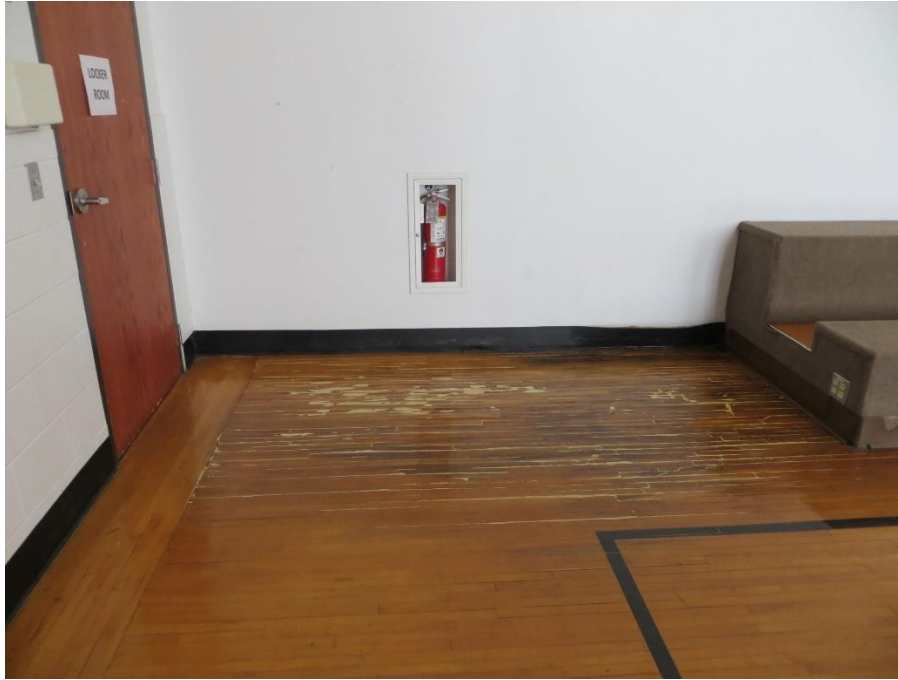
FIG. 12 GYMNASIUM WOOD FLOOR

- D. The existing wood floor in the gymnasium is in overall good condition, except for the section in the NE corner that has water damage (approximately 5'-0" W x 12'-0" L). There was a repair done to fix the wood shrinkage/warping. This portion of damage floor is not in the playing court area and could be left as repaired. The cause of the water damage was unknown.
- 1) Remediation: Remove portion of damaged wood floor (60 SF).
 - 2) New wood gym floor with sleepers/subfloor replacement.
 - 3) Estimated cost: \$5,000.

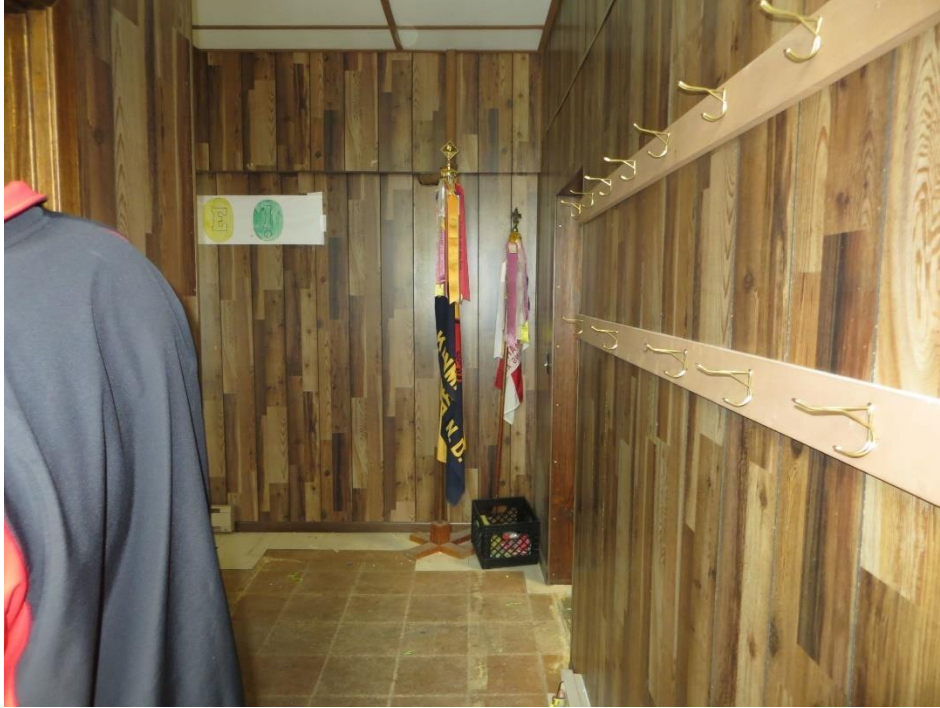
FIG. 13 EXISTING VCT FLOORING ON SECOND FLOOR

- E. Painted concrete floor in the lower-level lockers rooms are in good condition.
- F. The laminate flooring in the gymnasium lobby is in very good condition and looks to have been installed within the last 5 years.
- G. The VCT flooring in the kitchen, Men's & Women's toilet rooms, located south of the gymnasium are in good condition.
- H. The VCT flooring on the second-floor kitchen, craft room, and other areas on second floor south of the gymnasium are in poor to bad condition and should be replaced.
- 1) Remediation: Remove existing VCT flooring and adhesive. Asbestos testing of VCT & adhesive.
 - 2) Install new LVT (Luxury Vinyl tile) and vinyl base.
 - 3) Estimated cost: \$8,000.

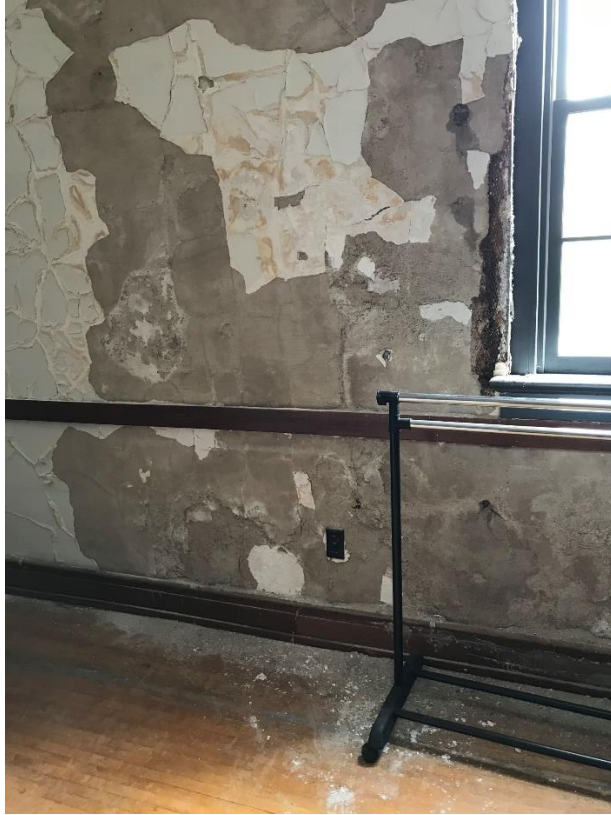
FIG. 14 PLASTER CRACKS ON SECOND FLOOR

- A. The interior walls of the existing building are in good condition, with exception of the east wall of the second floor Legion Room. There are many cracks in the plaster, as well as the paint/plaster section falling off the wall. The wall has crumbled down to the metal lath on one of the window jambs. This damage appears to be from previous water damage.
 - a. Remediation: Remove crumbling plaster and rusting metal lath.
 - b. Install new metal lath and re-plaster wall.
 - c. Estimated cost: \$2,500.

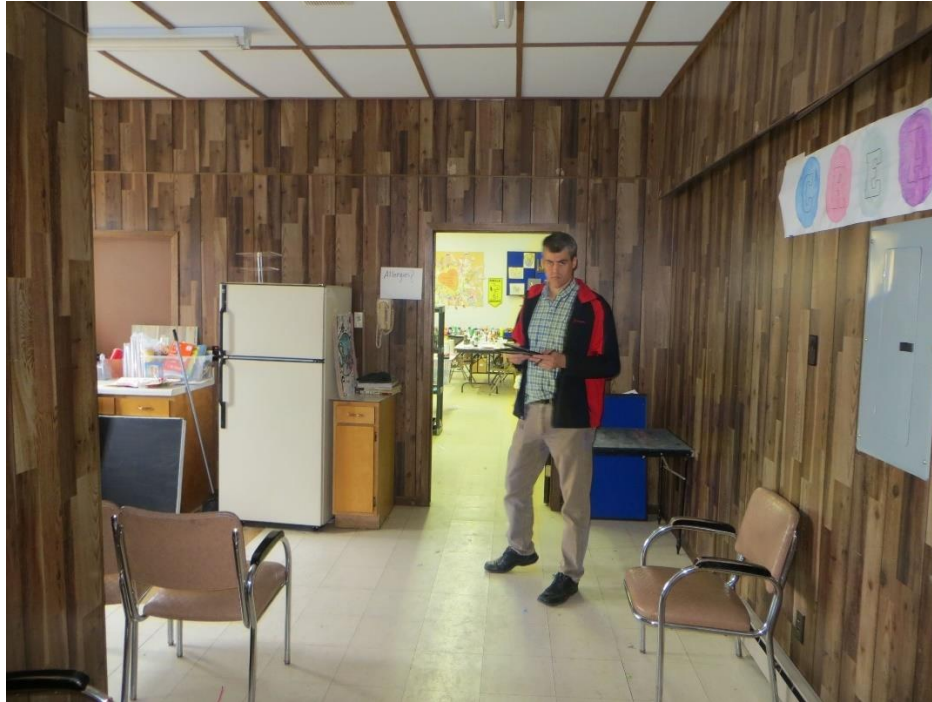
FIG. 15 WOOD PANELING WALLS ON SECOND FLOOR

- B. There are many walls on the second-floor craft room, kitchen, storage, & toilet room that are covered with a dark wood paneling that could be removed and walls painted to lighten up the spaces.
 - a. Remediation: Remove existing wood paneling and wood base.
 - b. Install new gypsum board sheathing, tape, texture, & paint. Install new vinyl base.
 - c. Estimated cost: \$7,500.

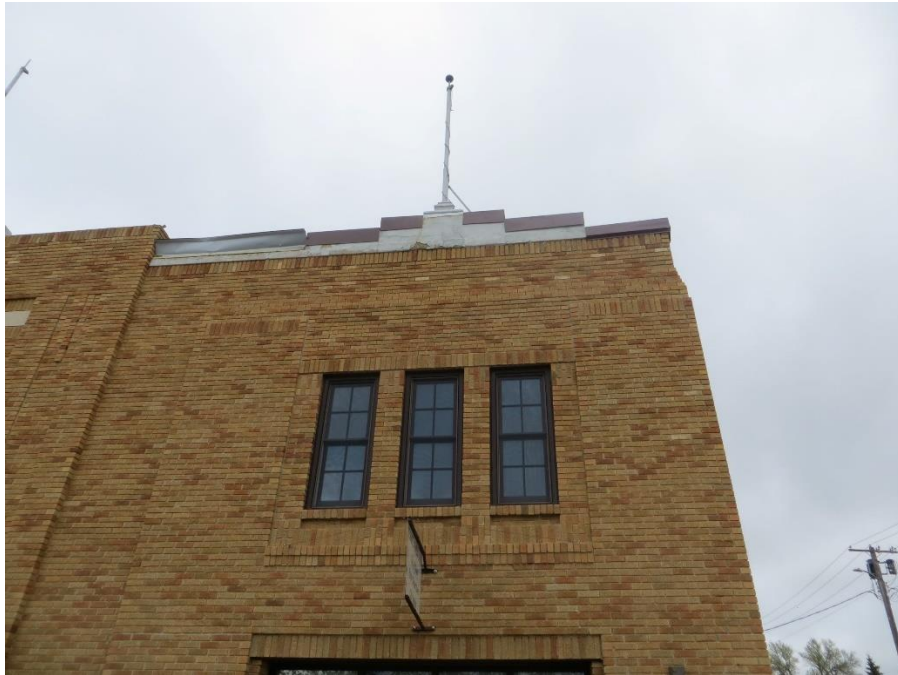
FIG. 16 EXISTING DOUBLE HUNG WINDOW UNITS

- A. The existing aluminum storefront windows at the south & west entrances are in good condition. The existing window units on the south & east of the building are wood framed double hung windows that appear to be original to the building and in good condition, but the glazing was single pane and was rattling during the heavy winds of the site visit. The existing single pane windows would not meet the current Energy Code for U-Factor of Thermal Transmittance.
 - a. Remediation: Remove Existing double hung wood window system and attachment items.
 - b. Install new double hung energy efficient windows and frames.
 - c. Estimated cost: \$26,500.

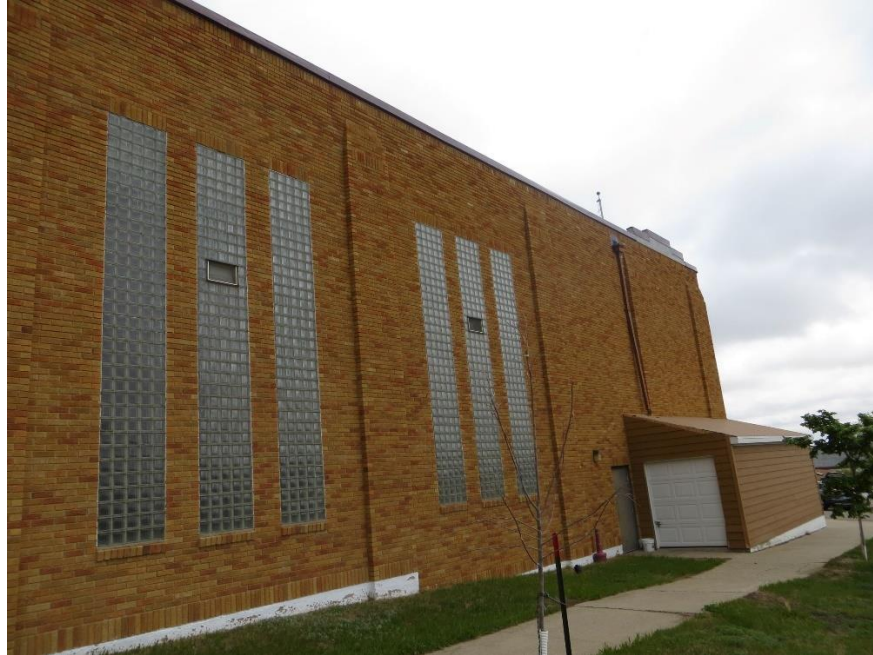
FIG. 17 EXISTING GLASS BLOCK WINDOWS AT WEST SIDE OF GYMNASIUM

- B. The existing glass block windows on the west side of the gymnasium are in good condition are appears to be original to the building. The glass block windows would not meet the current Energy Code for U-Factor of Thermal Transmittance.
 - a. Remediation: Remove Existing glass block window system and attachment items.
 - b. Install new aluminum storefront window system with energy efficient glazing.
 - c. Estimated cost: \$48,000.

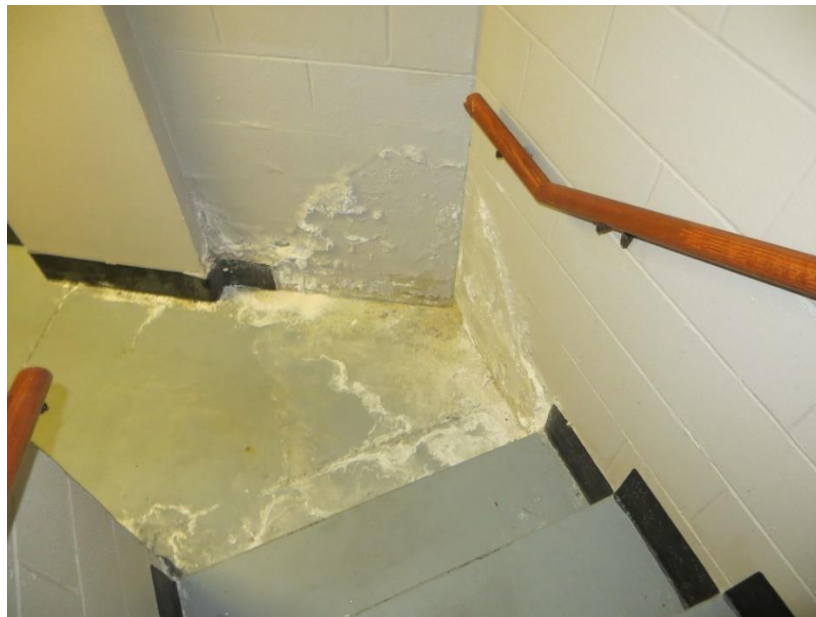
FIG. 18 EAST LOCKER ROOM STAIRS

- A. The building foundation seemed to be in good condition, except for the spalling and cracking of the stone/concrete base as described in the exterior evaluation.
- B. At the bottom of the east stairs of the lower level locker rooms, there is a lot of efflorescence on the cmu foundation walls and concrete floor. It appears that the cmu block had been sealed up to 2'-0" in height in the past, but the efflorescence had peeled away the sealer paint. The vinyl base had been removed in this section of wall.
